Experimental investigation of the use of ferrocement laminates for repairing masonry in filled RC frames

Abstract

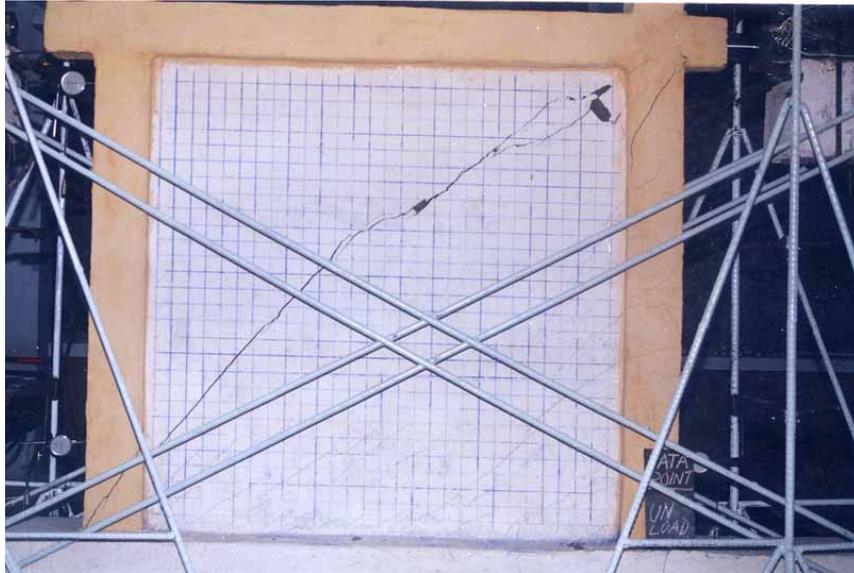
The masonry infilled RC frame was tested by applying monotonic lateral load at the top of the RC column up to initiation of failure. The surface of masonry infill (both sides) and all sides of column were colored white and yellow to facilitate the viewing of cracks. Load was increased stepwise at the rate of 1 ton per step until the failure occurred. Applied loads were recorded from machine dial gauges. The test was terminated when severe damage was observed in the specimen. Fig.5 shows the failed infilled frame with a prominent diagonal crack.

Fig.5. Failed infilled frame with a prominent diagonal crack.

Ferrocement technique was adopted to repair the distressed RC frame and masonry infill wall. At first the mortar cover was chipped off. The chipping process continued from either side of the crack. Fig.6 shows the distressed masonry infill panel after chipping off the mortar layer. After chipping, the surface was cleaned thoroughly and washed with a water jet to remove dust and loose debris. In order to ensure proper bond between crack surfaces, cement slurry was sprayed over the crack. Thereafter a thin layer of mortar was

applied all over the surface of the column and masonry. Afterwards, two layers of wire mesh were placed on columns and one layer mesh was placed on the infill on both sides, which were held in place by the previously affixed nails. Thereafter, the final layer of mortar was applied on the wire mesh. This mortar penetrated through the openings of the mesh and came in contact with the previously applied mortar thus securing the mesh in place with proper bonding. Finally, curing of the repaired frame was done by covering the rehabilitated region with hessian in moist condition.

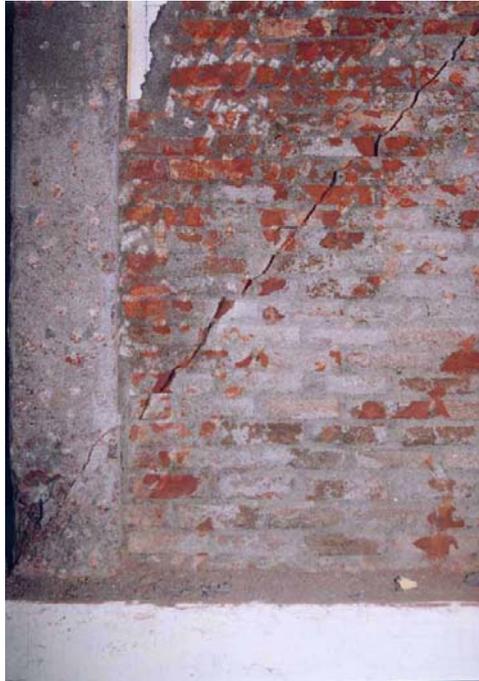
crack went through the masonry (Fig.6), which means that brick failure occurred. After the full failure of the frame and infill, the loading was stopped and frame was kept for repairing. The load deflection curve of the original frame is shown in Fig.7 with a continuous line.

Fig. 6. Close up view of the crack after the plaster is chipped off.

When load was gradually applied to the original frame, the frame deflected at the top, thereby causing shear deformation in the infill panel. The first visible crack appeared near the bottom of infill at the loading side at a load of 12 ton. The corresponding top deflection was approximately 4mm. The cracks were diagonal in nature. The corresponding shear strain can be calculated as 0.00262 radian. Thus it is possible to get an idea of the maximum shear strain that may be developed in infill to produce visible cracks. This first diagonal crack appeared at the furthest corner from the loaded compression diagonal. This indicates that the infill was substantially bonded with the base as well as with the column. When load was increased to 15 ton, several cracks parallel to the first one were observed. However, at this stage, horizontal cracks were developed in the column at the loading side. These cracks are developed due to the tension developed in the column. Development of such crack continued till 18 ton load. When the load reached 19 ton the frame with infill failed with a major diagonal crack as seen in Fig.5. Diagonal cracks were also observed at the top of the column on the loading side and bottom of the column on the leeward side. This indicates that the columns were weaker in shear. Observing the major diagonal cracks, it can be said that the infill failed basically due to diagonal tension. Also, the more or less straight nature of the crack reveals that the crack passed through brick infills. This is visible in Fig.6, which shows the damaged infill after the plaster is removed. The reasons behind failure

of bricks may be attributed to the fact that the mortar was probably stronger than the bricks.

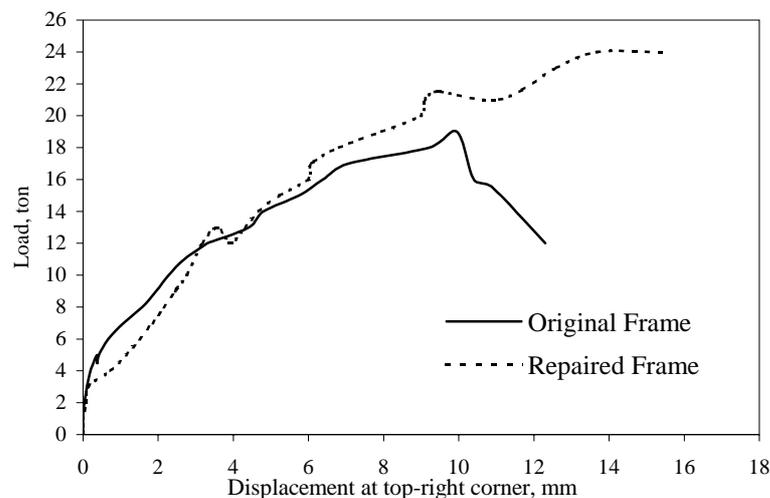
The repaired frame was tested in a similar fashion as the original frame. The first crack in the infill was formed at the bottom of the leeward side at a load of 16 ton. The corresponding deflections at the top and bottom were 5.99 mm and 1.87 mm, which are less than those of original frame (6.38 mm and 3.63 mm respectively). These cracks propagated vertically upward as the load was gradually increased. At a stage of loading of 23 ton, the repaired frame was failed as shown in Fig.8. Again, the diagonal cracks were observed at the top of the column at loaded side and at bottom of column at leeward side also, which can be seen in Fig.8. Load deflection curves of the rehabilitated infilled frame are shown in Fig.7 with the dashed line. It is also found that, for comparable loads, the deflections of rehabilitated frame are less than those of the original frame.

Fig.7 Load vs. displacement diagram of original and repaired frame

After the frame was repaired using ferrocement overlay, the tested capacity was even higher (23 ton). Comparison of the load vs. displacement characteristics of the original frame and repaired frame can easily be observed in Fig.7. This figure clearly demonstrates the effectiveness of the repair methodology using ferrocement overlay. Since the failure of the repaired frame was diagonal tensile failure, it can be inferred that the capacity of repaired frame depended on the tensile strength of the ferrocement. In the repaired frame, the cracks were not repaired. It can be thus said that the combined capacity of the two layers of ferrocement was higher than the masonry. If before applying ferrocement coating, the cracked masonry and column were repaired using epoxy grouting then these components could contribute to the load carrying capacity of the ferrocement. That would have resulted in even higher load capacity. It can, thus be said that, if ferrocement overlay is applied to any existing undistressed infill then the capacity of the infilled frame will be significantly higher.

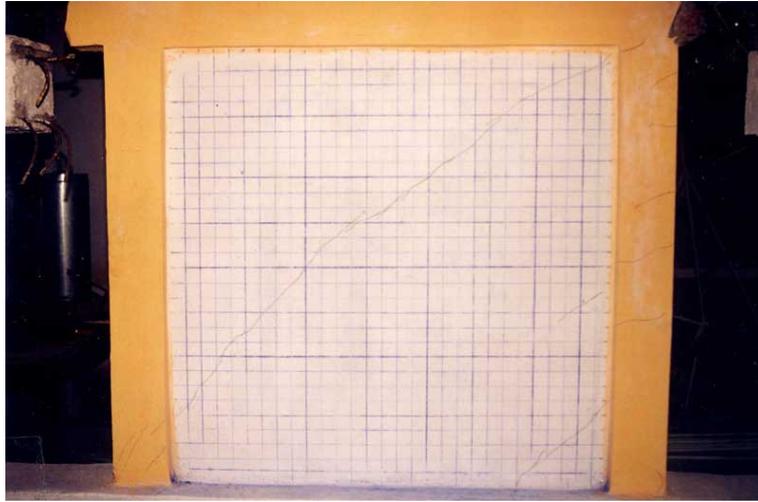
When the frame was repaired, the dimension of the sections of infill and the beam and columns were slightly changed due to the addition of ferrocement coating. In the original frame, the plaster was about 12.5 mm thick everywhere. In the repaired frame this thickness was about 19 mm. When the repaired frame was subjected to loading, cracks started appearing at 16 ton load, which is higher than the corresponding load of the original frame. These cracks propagated vertically upward as the load was gradually increased. At a stage of loading of 23 ton, the repaired frame failed with the occurrence of a major diagonal crack at the same location as was in the original frame. This is due to the fact that the cracks in the original frame were not repaired; instead, the whole frame was coated with ferrocement. This left the crack zones weaker than other parts of the frame and infill. As a result, cracks in the repaired frame occurred at the same location, as the cracks appeared in the original frame. It was, however, observed that the amount of crack opening (width of crack opening) was significantly smaller than those of the original frame. This reveals the superior capability of the ferrocement in protecting the damaged structure from environment. Fig.8 shows the repaired frame after failure in which the smaller width of cracks is visible when it is compared with Fig. 5.

Fig.8. Cracks in the repaired frame
