Investigation on erosion of Kuakata sea beach and its protection design by artificial beach nourishment

Md. Ataur Rahman¹, Manik Chandra Mitra² and Aysha Akter³

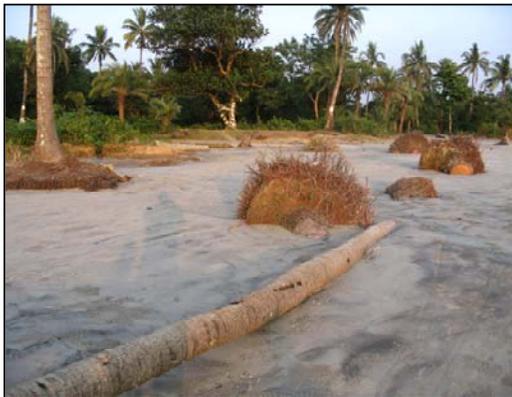
Fig. 2(a). Trees are uprooted due to beach erosion at Kuakata

The main beach of Kuakata, which is developed as tourist spot over years having the facilities of communication, commercial hotels etc, is situated at the west part. From the analysis it is seen that the west part of Kuakata beach has been suffering erosion since 1984 and it is still continuing. The photos of uprooted trees and failed flood embankment behind the west part of beach, shown in Figure 2, are taken by the authors at the end of year 2010 during the field visit. The authors observed that the natural beauty behind the beach such as coconut-mangrove garden, flood embankment behind it, tourist shopping market, LGED rest house and most of the hotels close to sea are under great threat of coastal erosion in near future. It motivated the authors to carry out a study on design of protection for beach erosion at Kuakata. Considering the advantages of restoring and widening the recreational beach, it is decided to design the artificial beach nourishment among various types of coastal protection options. As for example, seawalls may protect structures behind the beach, but they almost always cause the beach in front of the wall to become narrower. This study investigates the design of artificial beach nourishment at central 5 km eroded reach of main beach along west part of Kuakata and is described in this section.

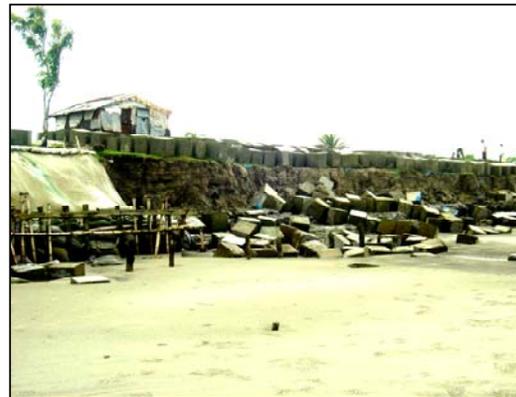
Fig. 2(b). Flood embankment behind the beach has failed under wave action

It is mentioned before that the continuous erosion along the western part of Kuakata beach has resulted the failure of earthen coastal embankment of polder no. 48. BWDB has designed the revetment type protection using cc block along the sea side slope of the embankment and has started to construct the protection works, which is temporary type protection to save the embankment from failure. Traditional coastal protection with hard structures like breakwater, groins, seawalls etc may protect the coastal embankment, but the beach will be completely washed out as because the hard structure attracts erosion in front of it. So this study suggests the soft structure coastal protection like artificial beach nourishment along eroded western part of Kuakata beach.

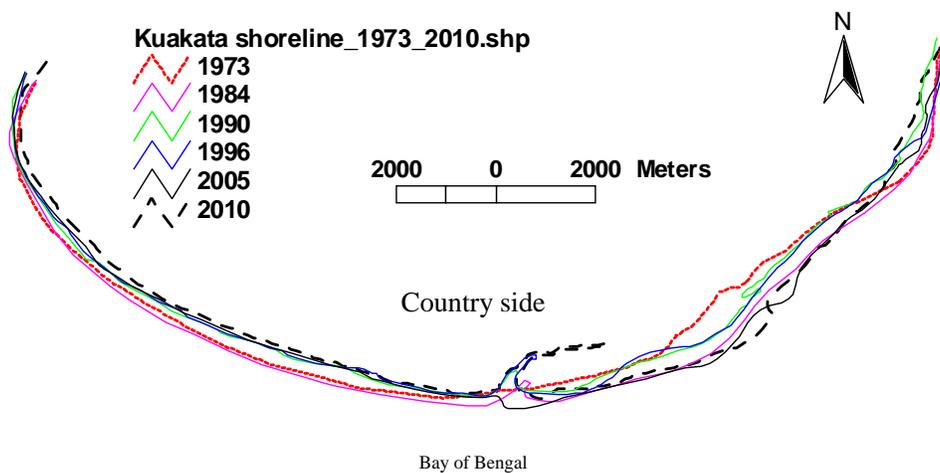
Fig. 3. Extracted shorelines from satellite images of Kuakata beach of different years

Figure 3 reveals that most of the western part of Kuakata beach happened to accretion during the period of 1973 to 1984, resulting a shifting of shoreline of 60 m to 80 m toward sea. After 1984 this reach started to suffer erosion which continued till the year of 2010. During this period most part of this reach had suffered erosion causing a shoreline shifting of around 350 m on an average toward inland, which had maximum value of 450 m. Analysis of eastern part, shown in Figure3, shows that most portion of this reach had been accreted during the period of 1973 to 2010. It is seen that after 1973 there started siltation in this reach which continued at faster rate till 1984. After 1984 this accreted zone suffered erosion till 1996. During the period of 1996 to 2010, again it caused a huge siltation there. Comparing the shorelines of 1973 and 2010, it is prevailed that most part of this reach had been accreted resulting the shoreline shifting of around 600 m on an average toward the sea, which had maximum value of 1075 m. It prevails that during the period of 1973 to 1984, the whole reach of Kuakata shore was silted up, which suffered erosion during the period of 1984 to 1996. After 1996 erosion continued along the western part till the year 2010, while it caused huge siltation in eastern part during this period. It indicates that long shore sediment transport causes erosion along western part and those eroded sediments deposit in the downstream resulting siltation along eastern part during the period of 1996 to 2010.

Very little field survey has been done so far in the coastal areas of Bangladesh including Kuakata due to the lack of financial and technical facilities. As a result, availability of data for coastal research is poor. Under such situation, remote sensing data can be used to effectively monitor the changes along the coastal zone with reasonable accuracy. This study hence applied satellite images to capture the changes of shoreline causing erosion or accretion along Kuakata beach. The satellite images of the Kuakata shore for the years of 1973, 1984, 1990, 1996, 2005 and 2010 have been digitized using ArcView GIS 3.3 Software. For quantitative comparisons of the shoreline locations, it is needed to georeference all the images with respect to some selected control points of known geographic coordinate. After georeferencing all the images the shoreline in each image was extracted by line digitizing. In this manner, regardless of the image resolutions, obtained shoreline positions are all based on the same coordinate system and thus should be readily comparable to each other in a quantitative manner. Fluctuation of tidal level is usually considered during identification of shoreline position in satellite image (Chen et al 2009). But due to non availability of measured long time tidal level data, this study considers the edge of the dry sand as the shoreline position. The extracted shorelines of six different years are shown in Figure 3. In 23.56 km long shoreline, erosion occurs along 13.59 km reach of west part, whereas siltation occurs along 9.97 km reach of east part of the Kuakata beach.

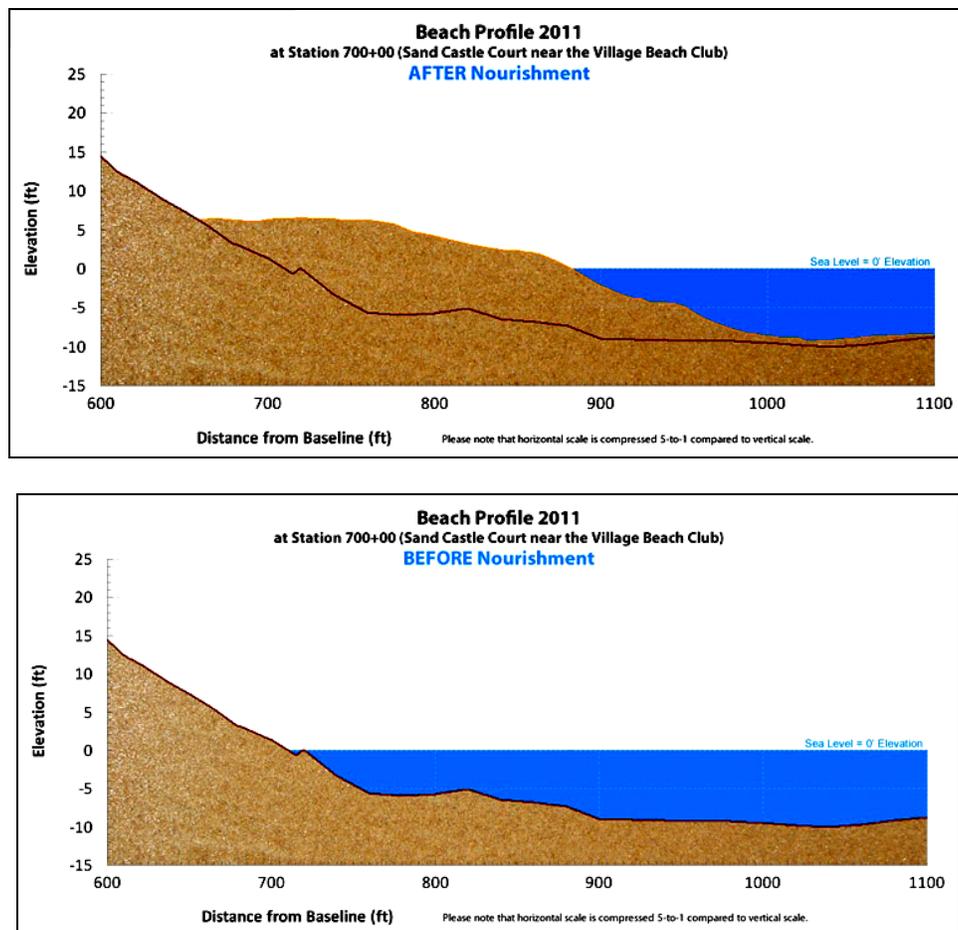
Fig. 4. The profile of Nags Head beach at North Carolina, USA (before and after nourishment)

Beach nourishment is the replenishment of beaches with imported sand and is one of the best available means of restoring beaches where erosion has become a problem (Figure 4). Sand nourishment increases the width of land available to accommodate erosion, while at the same time allowing the beach to continue to behave naturally. Nourishment has gained popularity because it preserves beach resources and avoids the negative effects of hard structures. Instead, nourishment creates a soft structure by creating a larger sand reservoir, pushing the shoreline seaward. Risio et al (2010) investigated the cross-shore short term changes of protected and unprotected beach nourishments through laboratory experiments. Dean et al (2011) studied the performance of beach nourishment project in Florida.

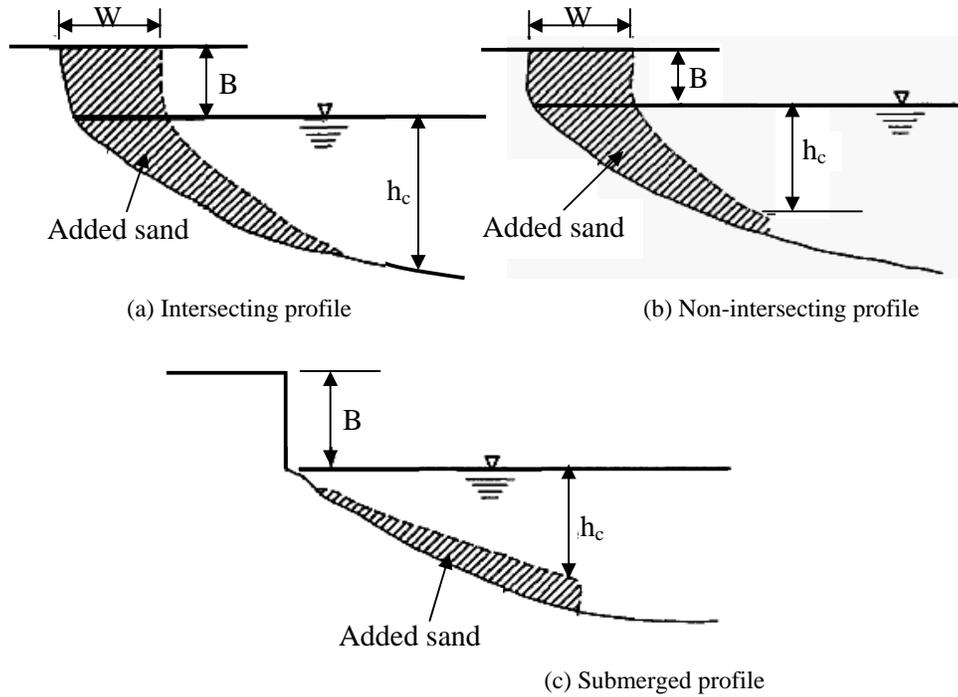
Dean (1991) defines three basic types of nourished profiles - an intersecting profile where the profile after nourishment intersects the equilibrium profile before closure depth, a non-intersecting profile where the nourished profile does not intersect the equilibrium profile before closure depth and a submerged profile where there is no dry beach after equilibrium (Figure 5). Dean shows that whether a profile is intersecting or non-intersecting is determined by the following equations:

Fig. 5. Three basic types of nourished profiles (adapted from Dean 1991)

$$W \left(\frac{A_N}{h_c} \right)^{\frac{3}{2}} + \left(\frac{A_N}{A_F} \right)^{\frac{3}{2}} < 1 \quad (\text{for intersecting profile}) \quad (2)$$

$$W \left(\frac{A_N}{h_c} \right)^{\frac{3}{2}} + \left(\frac{A_N}{A_F} \right)^{\frac{3}{2}} > 1 \quad (\text{for non-intersecting profile}) \quad (3)$$

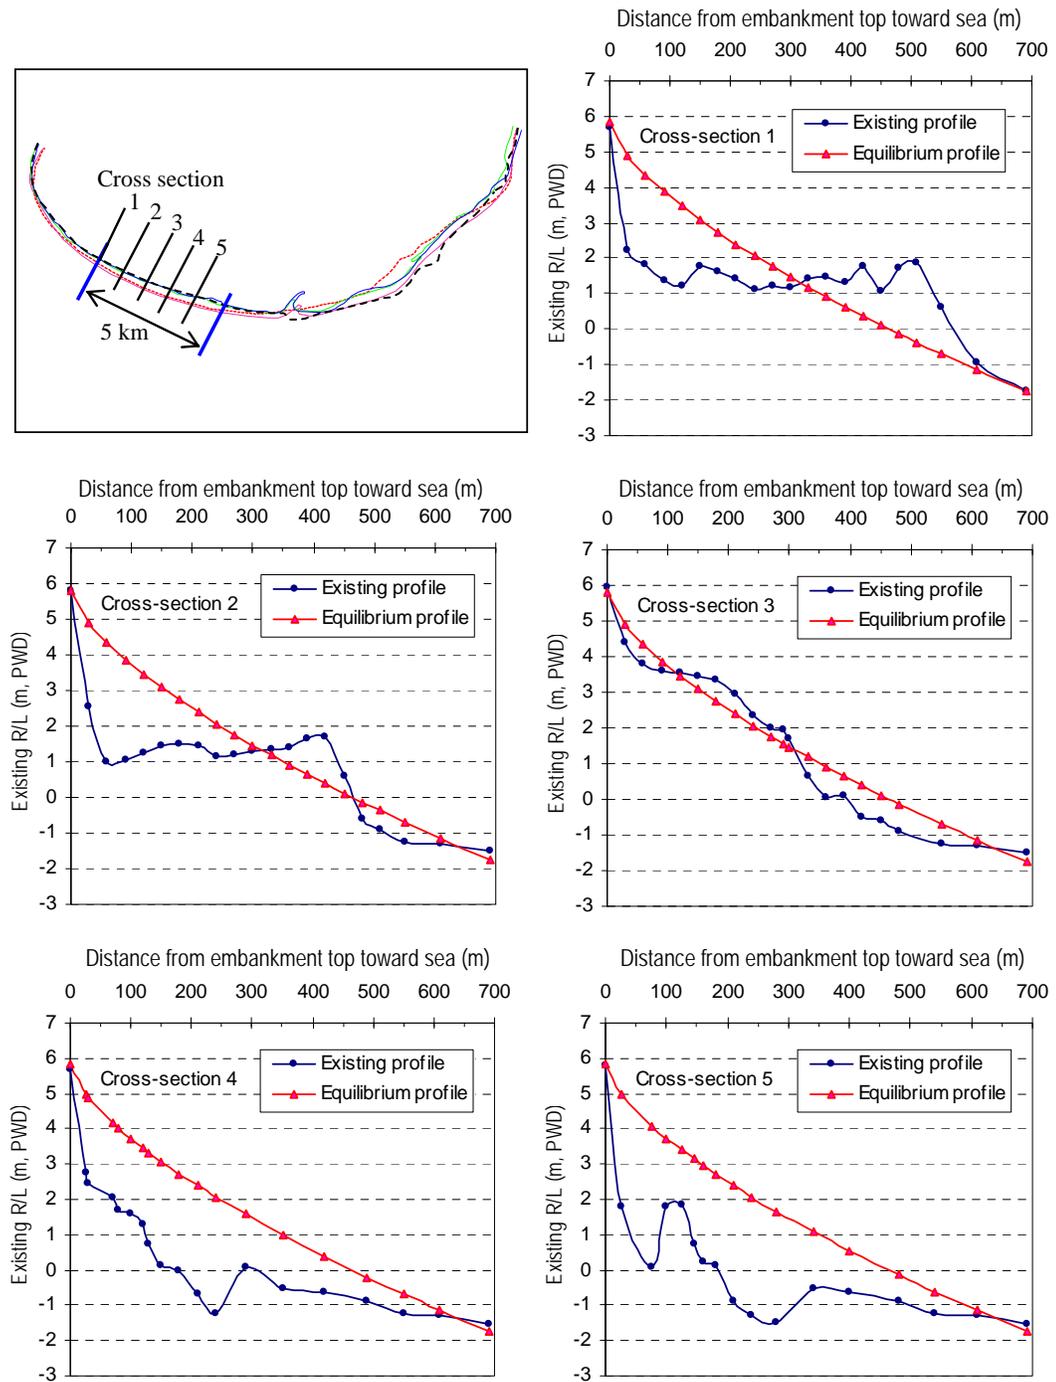
To design the beach nourishment, a 5 km reach of eroded part at the main beach of Kuakata has been considered in this study. The beach cross section data measured on 2010 at 5 sections with 1 km interval have been plotted as existing profile and the equilibrium profile defined by Eq. (1) is plotted as equilibrium profile, which are shown in Figure 6. At first the existing profiles should be prepared so that it coincides with equilibrium profile. After calculating the volume differences between existing and equilibrium profiles at section 1 to 5, it is averaged along the design beach reach which calculates the sediment volume as 584 m³/m. After beach profile in the design reach is prepared as equilibrium profile, the volume of nourished sediment per unit beach length is calculated by Dean's method mentioned above. From the collected data it is found that the size of the native material at Kuakata beach is 0.20 mm (which makes $A_N=0.097$) and the nearshore average significant wave height of 1 m (Bhuiyan et al 2005) makes the closure depth as $h_c=6.75$ m. In the design it is considered the dry beach width of 40 m and berm height of 2 m. Three different sizes of fill material are considered as 0.15 mm (fill sediment size less than native sediment size), 0.20 mm (fill sediment size equals native sediment size) and 0.25 mm (fill sediment size greater than native sediment size), which makes A_F values of 0.084, 0.097 and 0.108 respectively. Eq. (2) and (3) determines that the nourished beach profile will be non-intersecting for fill sediment size 0.15 mm and 0.20 mm, whereas it will be intersecting for fill sediment size 0.25 mm. Using the Eq. (4), (5) and (6), the volumes of nourished sand to be placed after the equilibrium profile per unit beach length are 849 m³/m, 350 m³/m and 177 m³/m for fill grain size of as 0.15 mm, 0.20 mm and 0.25 mm respectively. By adding the net sediment volume required to prepare the existing beach profile to equilibrium profile and the nourished sediment volume calculated by Dean's equations, the design nourished sediment volumes at 5-km reach of eroded part at the main beach of Kuakata have been estimated as 1433 m³/m, 934 m³/m and 761 m³/m for fill grain size of as 0.15 mm, 0.20 mm and 0.25 mm respectively.

Fig. 6. Existing and equilibrium profile measured from embankment top toward sea at five cross-sections along the five km long eroded reach at main beach of Kuakata
