Rail-road traffic interaction at Shaheed Ahsanullah Master Flyover

Nafis Anwari¹, Md. Rakibul Islam² and Md. Shamsul Hoque³

Among the six partially-grade separated flyovers constructed in Dhaka till July 2017, Shaheed Ahsanullah Master Flyover was found to be in the worst operating condition for at-grade traffic movements. A field investigation was conducted to identify and evaluate the at-grade traffic movement at Tongi Level Crossing under the flyover. The identified problems that exacerbate rail-road conflict include occupation of vehicular and pedestrian traffic on both sides of road, on-street parking, high elevation at level crossing, and excessive crossing time taken by trains. Detailed analyses of data and Computer Aided Drawing (CAD) are made to investigate the problems. At the level crossing near Tongi Railway Junction, which is one of the busiest railway stations in Dhaka City, trains are found to be crossing at slower than usual speed. Field observation revealed that average crossing time in Tongi Level Crossing is nearly double that of the other crossings using passenger trains. As compared to passenger trains, in general the freight trains take 30% longer time to cr

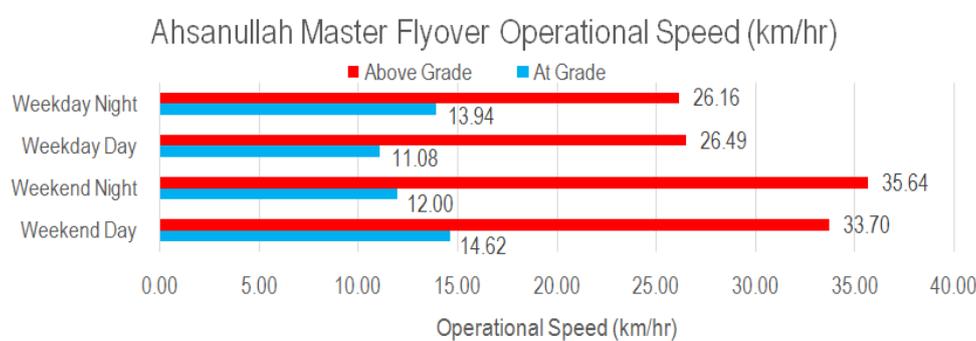
Fig. 4. Vehicle Operational Speed of Ahsanullah Master Flyover.

The combined average speed at night was 30.89 km/hr above grade and 12.54 km/hr at grade. So there is little variation in speed between day and night, meaning traffic speed is similar at both times. The combined average speed at weekday was 26.38 km/hr above grade and 11.80 km/hr at grade. The combined average speed at weekend was 34.62 km/hr above grade and 13.36 km/hr at grade. In this regard a weak relationship was observed between vehicle flow and average speed. Increase in vehicle flow reduced average speed and vice-versa.

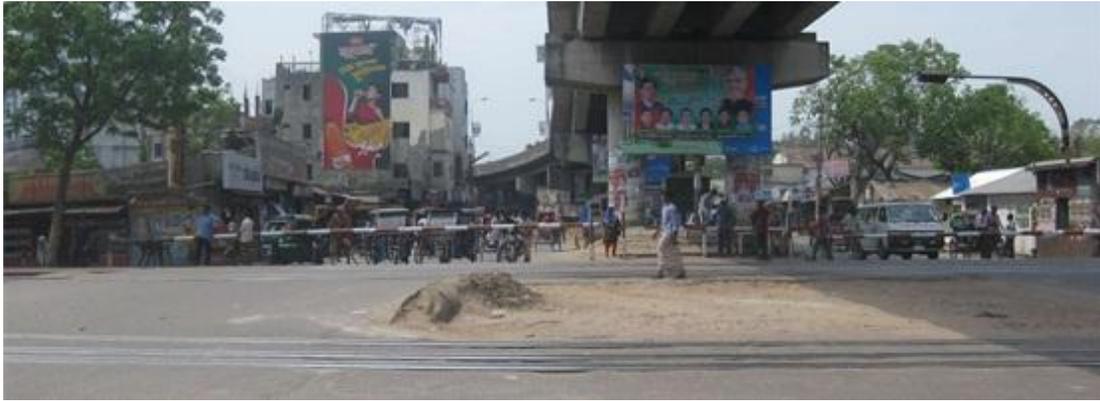
Fig. 5. Approach Road to Level Crossing (Towards Notun Bazar).

During field observation, it is often seen that traffic coming from one direction ends up occupying both sides of the road, as shown in Figures 5 and 6. This occurs when the level crossing gate is lowered to obstruct vehicular flow. As the vehicles line up and wait for the train to pass, many of them move forward illegally to occupy the lanes intended for use of vehicles of opposite direction. The reason behind illegally occupying the lanes of opposite direction vehicle is to pass the rail crossing within the quickest period of time immediately after the train passes and barriers have been raised to allow vehicle movement. However, this type of queue formation significantly hampers traffic discharge when all the waiting vehicles start moving together. While discharging, the vehicles on the wrong side of the road eventually have to shift to the original lanes and the resultant traffic flow acts like a semi roundabout. Eventually this especial traffic circulation reduces the mobility and increase time of crossing. This bizarre traffic situation is portrayed in Figure 7 and Figure 8.

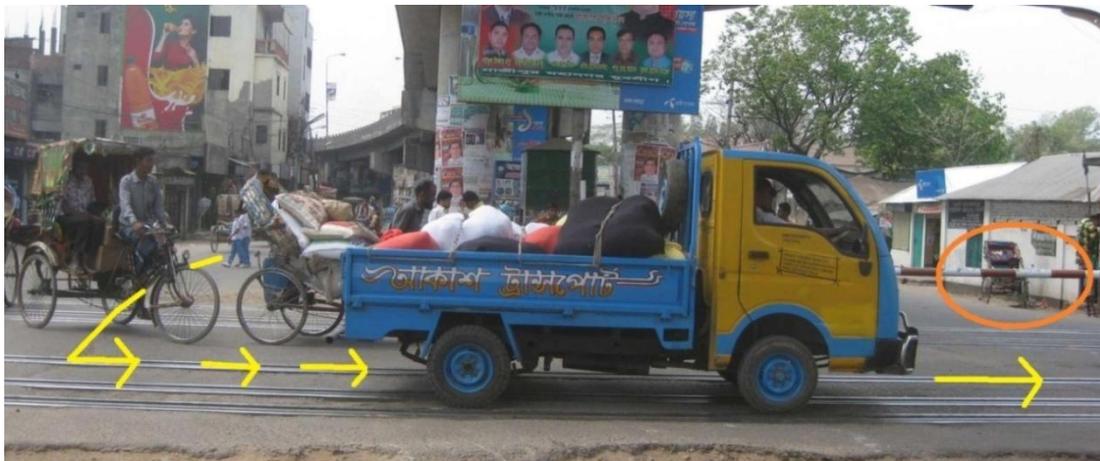
Fig. 8. Vehicular Flow at Level Crossing.

Figure 8 shows how vehicles cross after the barrier in the original direction (circled orange) have been lowered. Figure 8 shows that vehicles from both directions are trying to pass the crossing using the same lanes. Figure 9 describes at-grade road traffic movement pattern. The green arrows indicate the path taken by vehicles coming from Notun Bazar approach, while blue arrows indicate vehicles coming from Zakir Super Market approach. The red lines represent the median of the road. As shown on Figure 10, vehicles coming from Notun Bazar approach occupy both sides of the road. When crossing the intersection, the vehicles on the wrong side of the road have to switch to the original side, as shown by the clockwise movement at intersection using green arrows. The similar is true for vehicles from the other

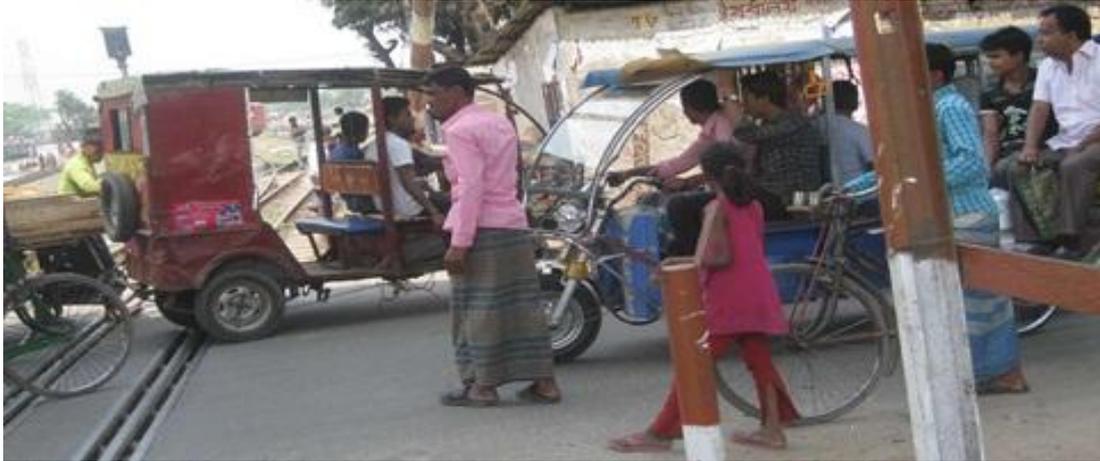
Fig. 9. Vehicular Flow Exiting Level Crossing.

approach. The two clockwise movements in the intersection decrease mobility at the intersection, and of the vehicles that started from the wrong side of the road on the pretext of reducing travel time experience otherwise.

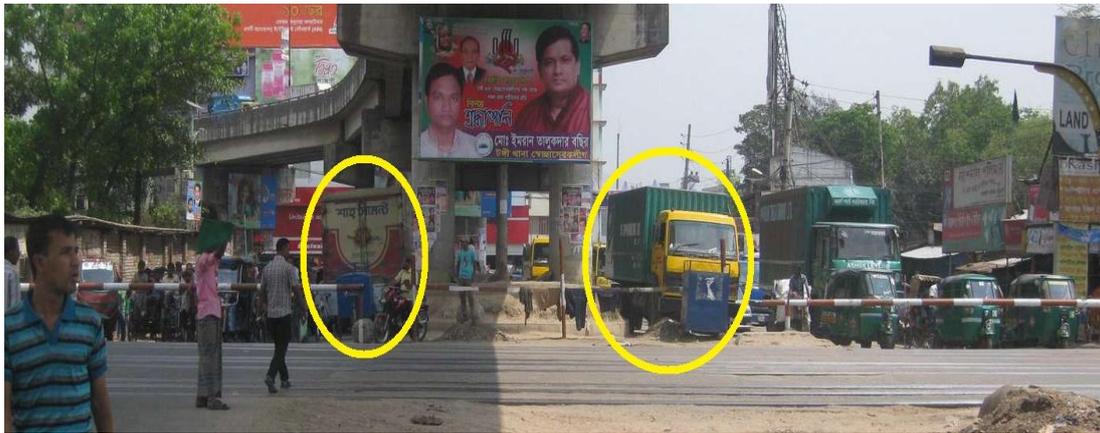
Fig. 11. Illegally Parked Trucks (circled yellow) near Rail-Road Intersection.

Vehicles have been observed to be parked illegally on the approach roads, as shown in Figure 10 and Figure 11. It is alarming to observe that the parked trucks (circled yellow in Figure 6) at the beginning of the rail-road intersection. Subsequently, on-street parking reduces the effective road width and capacity, further reducing mobility, as can be seen in Figure 11. Figure 11 shockingly demonstrates that the effective road width decreases by 7 feet, meaning only one-and-half lane, i.e. 70% of total road width is available to traffic. To analyze the extent of impact of parking on traffic flow and to understand the reasons for parking the vehicles, an open ended structured questionnaire survey was used. The sample size was mentioned in the methodology section. The questionnaire survey has revealed surprising results. The CNG drivers use the space as CNG stand, which was observed to have been occupied by 15 CNGs for 12 hours (8 am-8 pm). During that time some vehicles left the stand while others entered to fill the empty spots. Each vehicle may be kept there for as long as 24 hours if the driver doesn't get any customers. In addition, there is a stand for private vehicles which can be rented, which was observed to have been occupied by 8 cars.

The surveyed truck had slightly differing characteristics as compared to those of other vehicle classes. On average, trucks parked for 12 hours closest to the intersection, as revealed in Figure 10. Basically these are commercial goods carrying trucks and park under the flyover for the purpose of loading and unloading goods. The surveyed trucks handled goods such as electronics, steel reinforcement bars, crockeries etc.

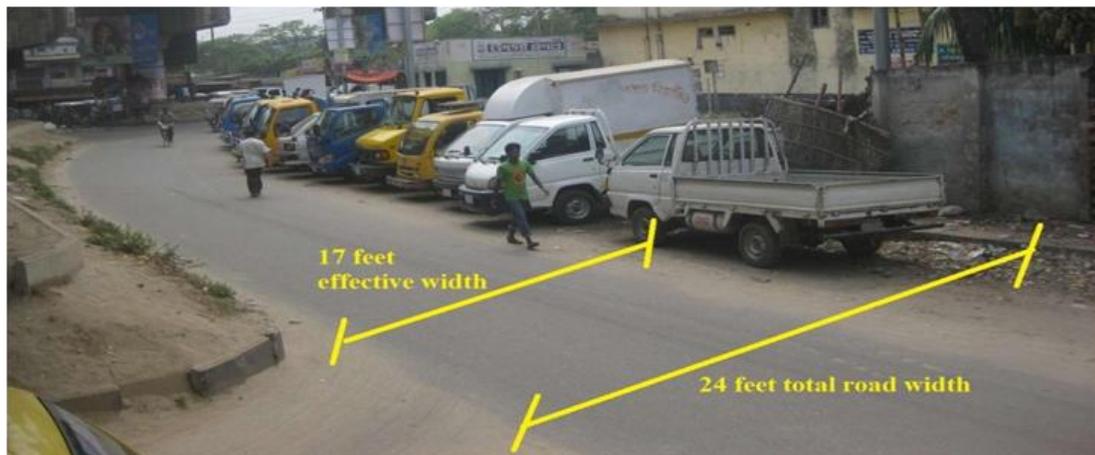
Fig. 12. On-street parking at Approach Roads.

Moreover, a pickup stand accommodating 10 pickups was present. Pickups can be privately rented to carry goods. The above three classes of vehicles had similar average parking times, meaning they affected traffic flow for 24 hours per day. The respondents stated that they usually did not face any restriction from authorities, except on certain days when the police evict them temporarily. However, the vehicles return to parking in the usual places as soon as the police leave.
